This document serves as a guide only and does not supersede clinical judgment.

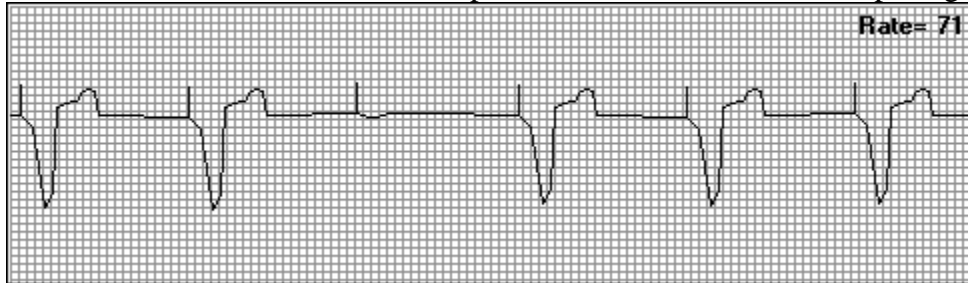
4. Failure to capture occurs when the pulse generator fires an electrical impulse, but that impulse does not cause a corresponding depolarization (pacer spike without corresponding QRS complex). This may be due to lead migration or dislodgement. First, increase the voltage of the pulse generator until you see 100% capture on the monitor. If this does not result in capture, switch to transcutaneous pacing.
